APPLICATION FOR A DLNR DAM SAFETY CONSTRUCTION/ALTERATION PERMIT PERMIT NO. 38 – KAPALAALAEA RESERVOIR (HI00094) OUTLET PIPE REPAIR, PAIA, MAUI

Application for a Dam Safety Construction/Alteration Permit for outlet pipe repair at the Kapalaalaea Reservoir/Dam (HI00094), Paia, Maui, TMK: 2-2-800:7001 See Exhibit 1.

Kapalaalaea Outlet Repair Scope of Work East Maui Irrigation

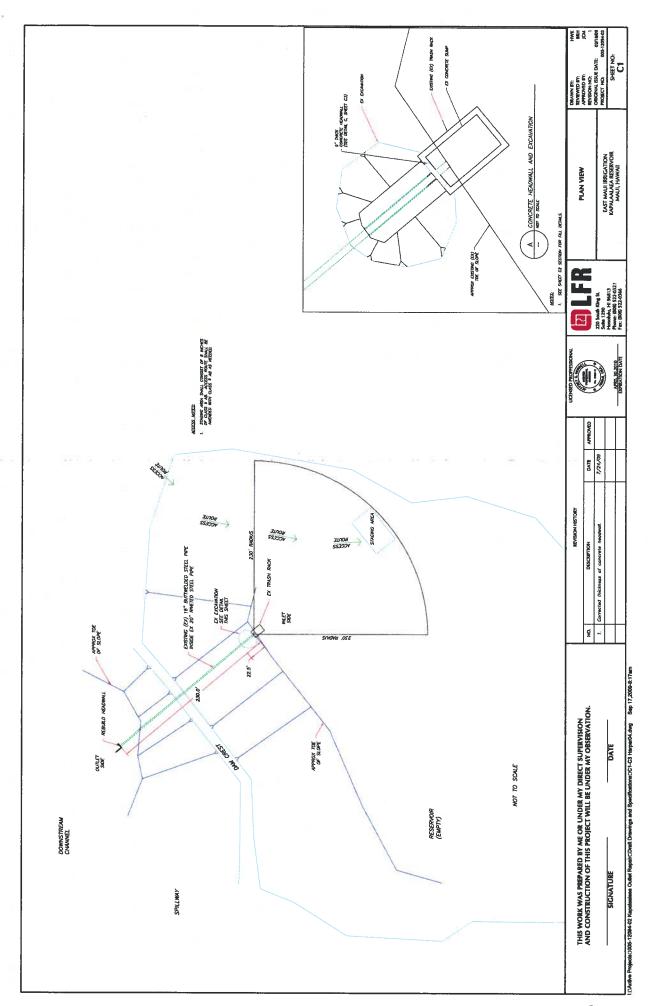
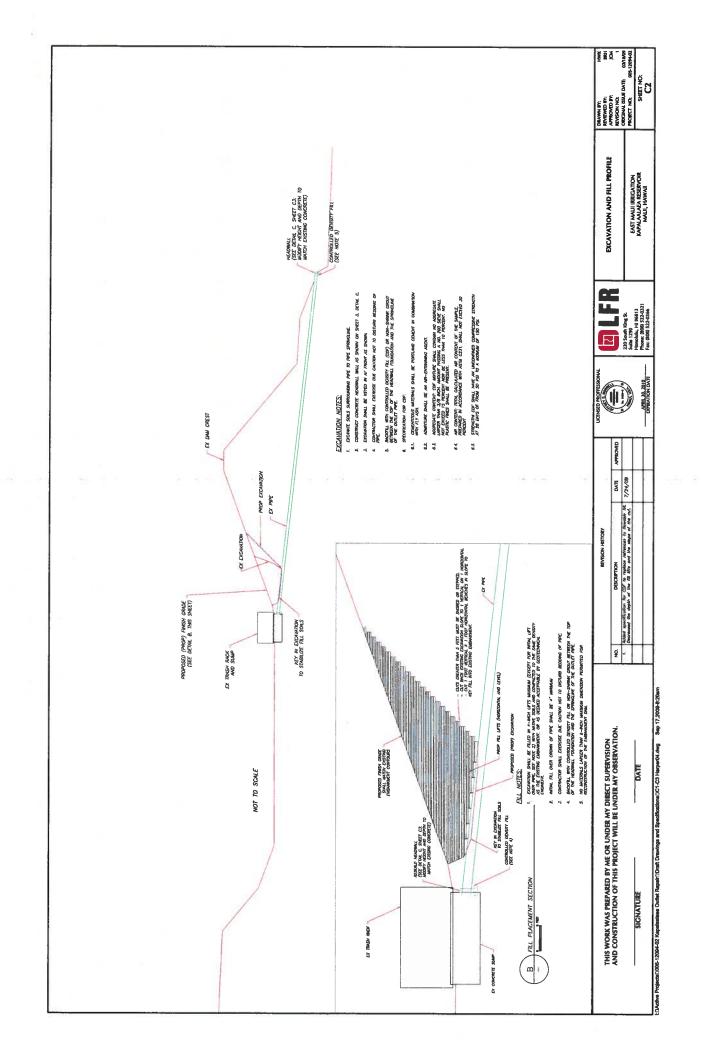
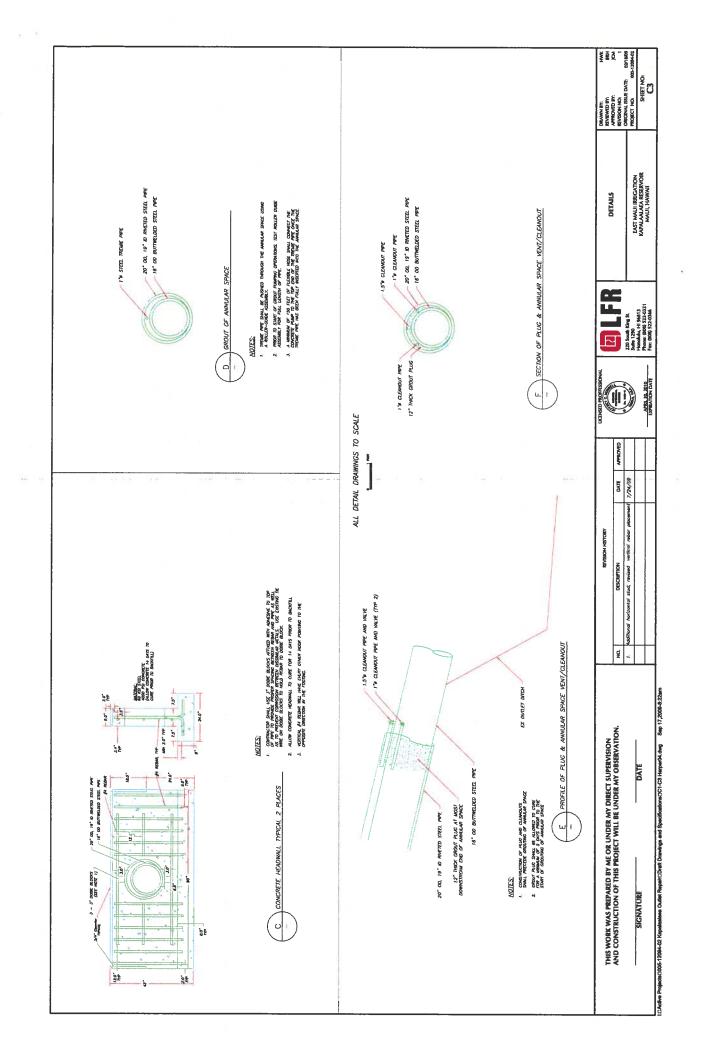
- A. Replacing soil (Refer to drawing sheets C1, C2, and C3)
 - i. Initial fill over crown of exposed outer pipe will be a 4" minimum lift.
 - ii. Contractor shall exercise due caution not to disturb the bedding of the pipe.
 - iii. Less than one cubic yard of controlled density fill shall be used to fill the void under the pipe and above the T-base of the headwall foundation at the upstream and downstream terminus of the outlet pipe. Controlled density fill shall be installed under the direction of the LFR geotechnical engineer.
 - iv. Excavation shall be filled in 4-inch maximum lifts with native soils and compacted to 95% modified proctor at 2% wet of optimum moisture content, or as deemed acceptable by geotechnical engineer.

- i. Existing cuts shall be cut back to 1V:1H slope and benched as shown on Sheet C-2
- ii. The final slope is the match the existing 2 horizontal: 1 vertical slope.
- iii. Four inch plus basalt rock will replace riprap on the slope to match the existing extent of rip-rap.
